HYDRAULIC INDUCED INSTABILITY ON A VERTICAL SERVICE

WATER PUMP: CASE HISTORY

R.F. Bosmans
Bently Rotor Dynamics Research Corporation
Minden, Nevada 89423

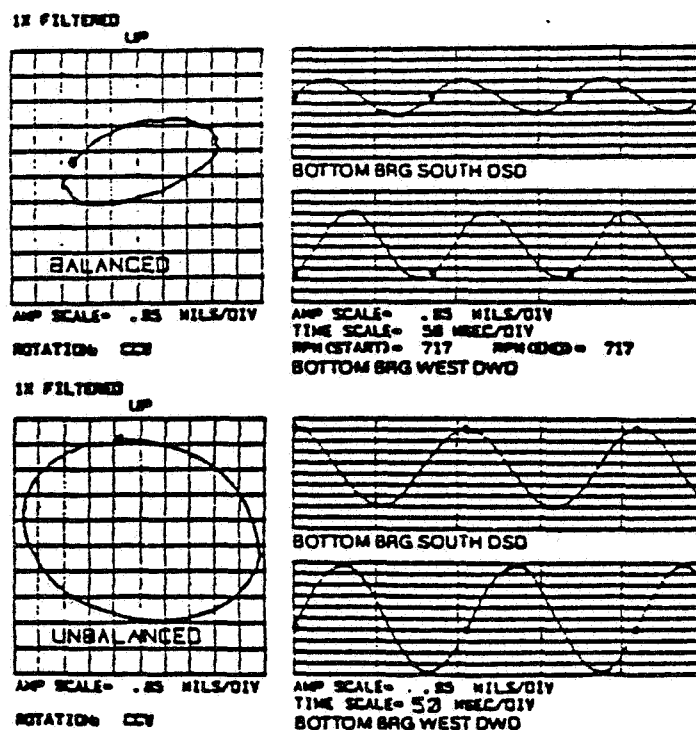
Figures 4 and 5 show orbit and time-base plots of trial runs with and without the imbalance weight. These measurements were taken at the lower bearing (location D) and at location B. Note that the plots at the lower bearing (D) clearly show the effects of unbalance but the plots at the upper bearing (B) do not show a significant change.

Figure 4. - Bottom-bearing orbit and time-base plots with and without imbalance weight.

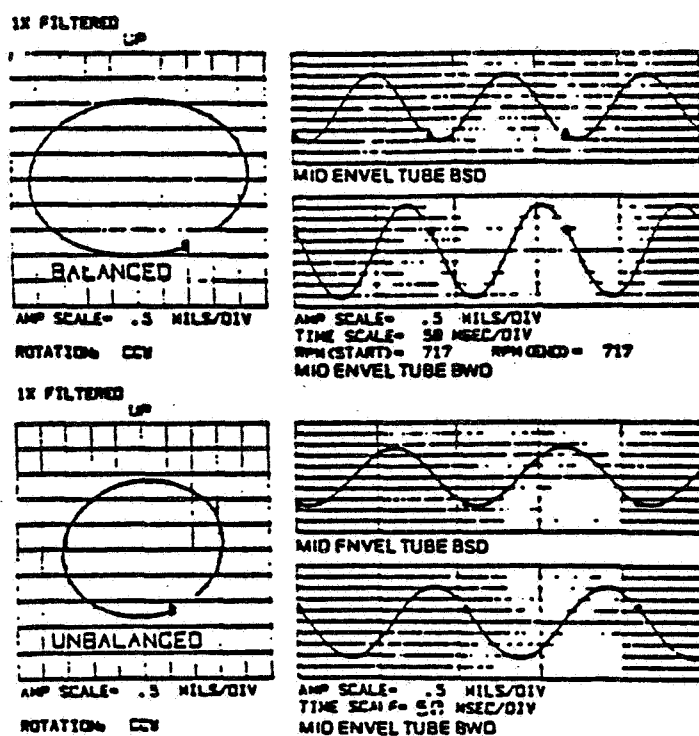
Figure 5. - Upper-bearing orbit and time-base plots with and without imbalance weight.

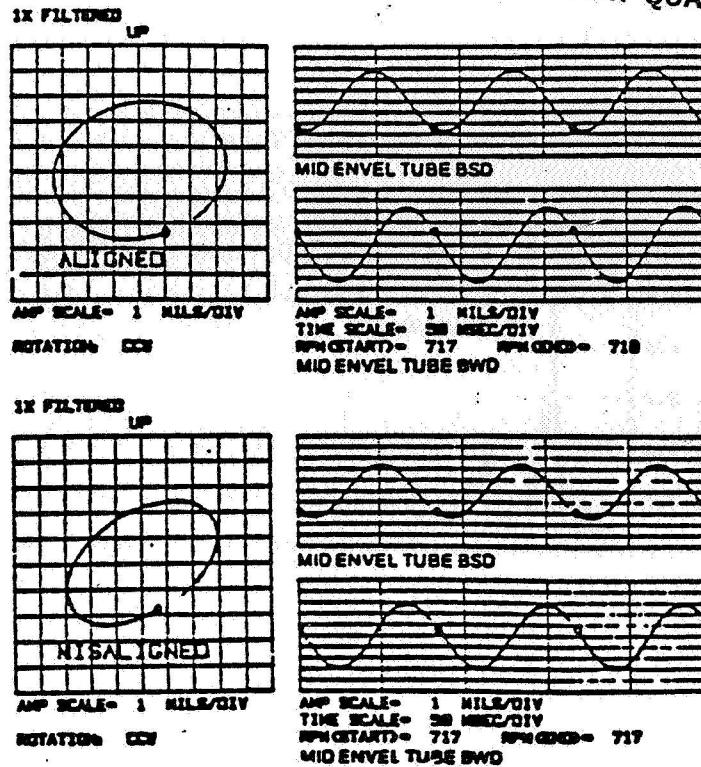
The alignment between the motor shaft and the pump shaft was changed by adding a 0.010-in shim under one side of the motor. This resulted in an angular misalignment of approximately 2°. Radial offset is impossible with this type of coupling. Orbit and time-base plots of data at location B are shown in figure 6. The slight elliptical shape of the orbit on the second trial run indicates a preload caused by the misalignment. Spectrum plots of the same data (fig. 7) do not give strong indication of misalignment. Since the misalignment manifests itself as 1x vibration, no strong indication of traditional 2x misalignment is indicated on the spectrum plot. The preload was not as apparent at the bottom bearing, as expected.

Figure 6. - Upper-bearing orbit and time-base plots with misalignment.

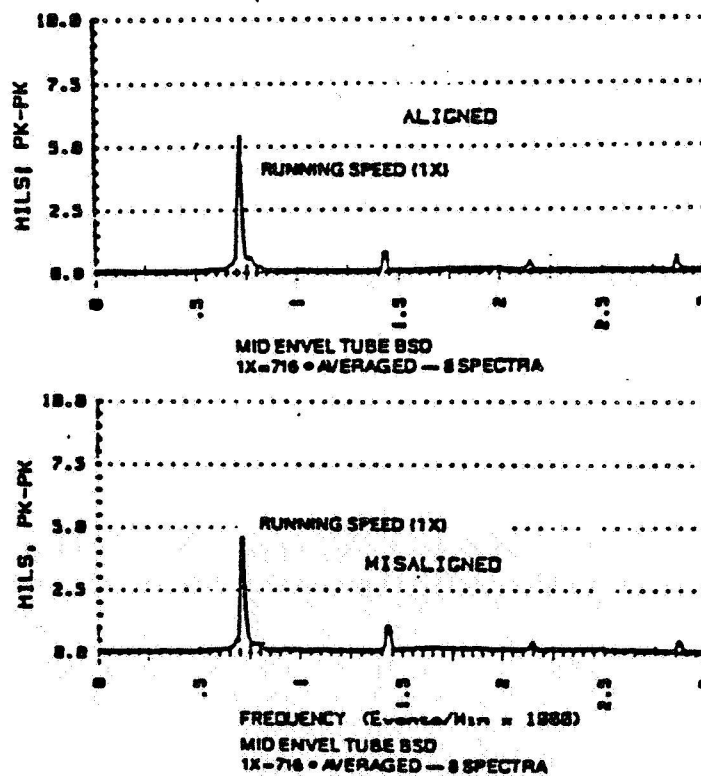
Figure 7. - Upper-bearing spectrum plots with misalignment.

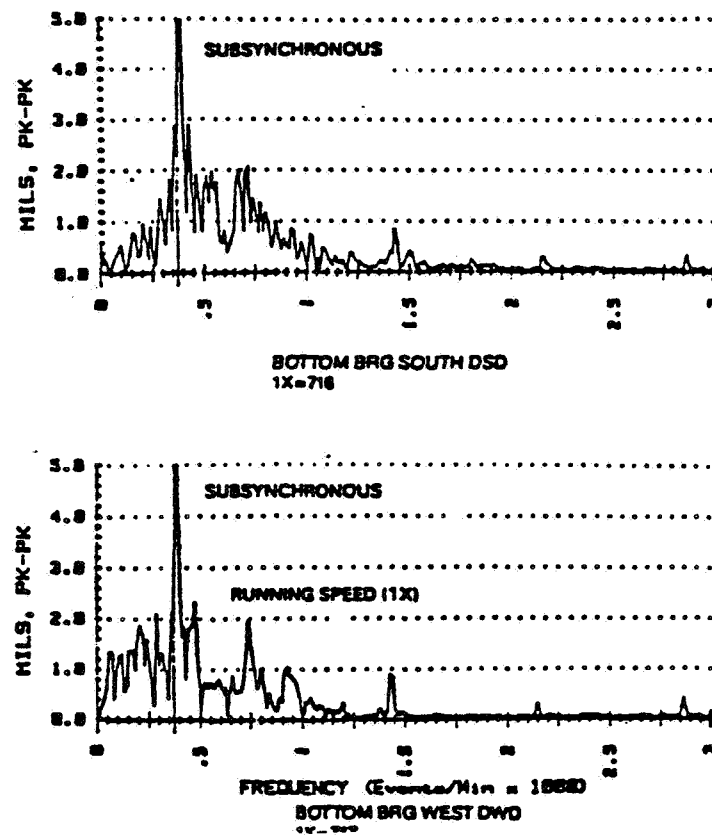
The pump was run with two different clearances between the leading edge of the impeller and the casing. Tests were conducted with design clearance of 0.043 in and excessive clearance of 0.200 in. The discharge pressure decreased by 20 psig with the increased impeller clearance, which is a good indication of the amount of recirculation and efficiency losses. With design clearance, spectrum plots of proximity probe data from the lower bearing showed strong subsynchronous response at 372 cpm (fig. 8). This frequency is the first lateral natural frequency (critical) of the pump shaft. When the clearance was increased, the subsynchronous vibration became less stable and occurred over a broader frequency range. As observed earlier with the balance response testing, the transducers located near the motor were unable to measure the subsynchronous activity on the impeller.

The hydraulic response testing determined that the excitation of the first balance resonance by the subsynchronous vibration was the cause of the recent shaft failure. These failures were diagnosed as bending fatigue failures by metallurgical analysis. However, several unanswered questions remained:

When maintenance records were researched, it was found that the start of shaft failures was preceded by a change in the supplier of the impellers. Recent impellers were not purchased from the original equipment manufacturer (OEM). The OEM has indicated that subtle changes in the blade attack angle could cause the reexcitation of the first lateral natural frequency (critical) because of vortex shedding.

Figure 8. - Bottom-bearing spectrum plots showing subsynchronous vibration component.
